Number 214

AGS Studies Report

Subject Direct Observation of Primary PUE Signals

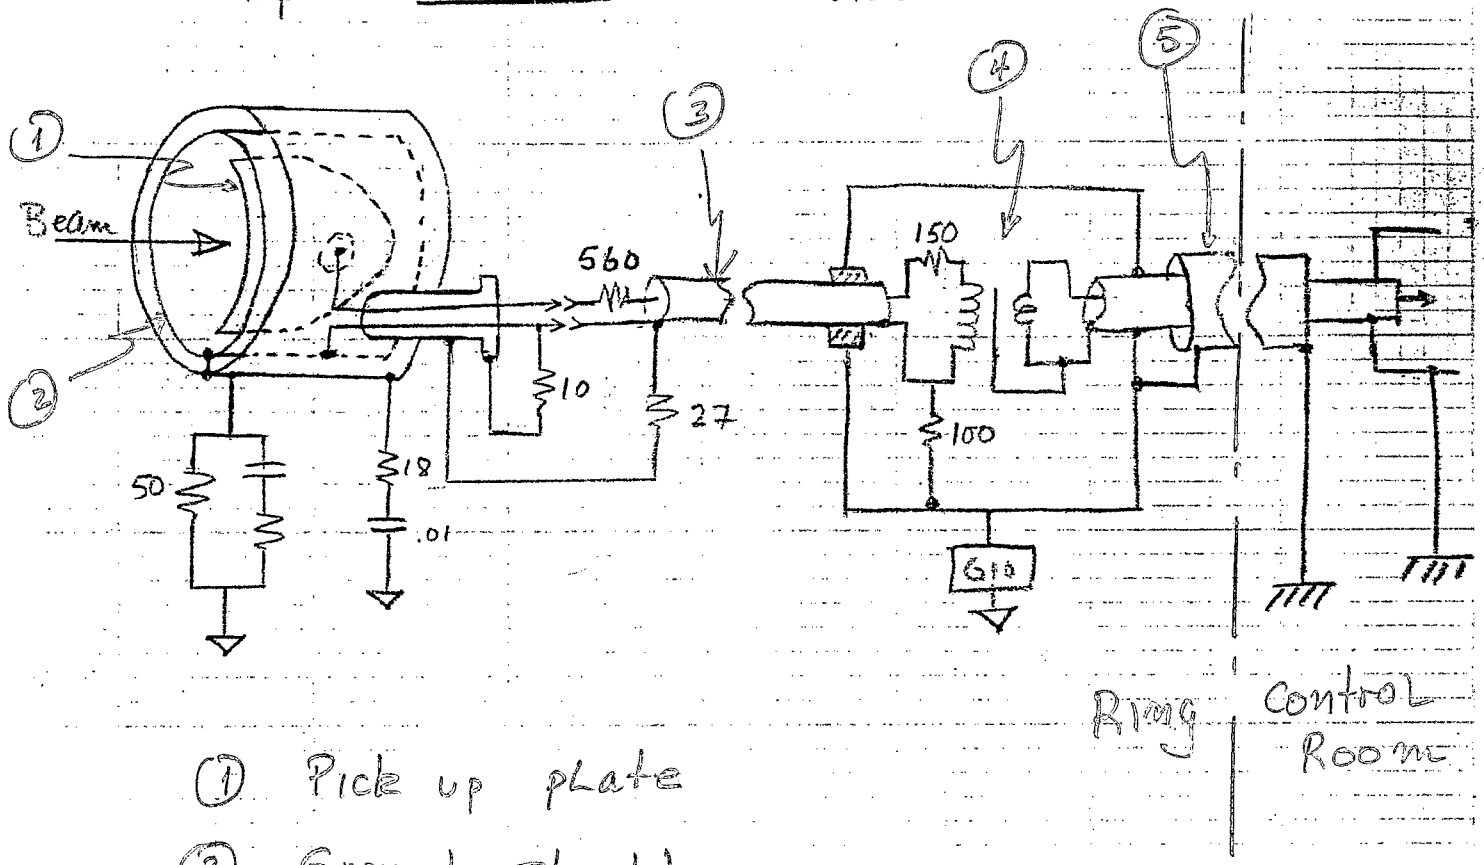
Figure 1
Schematic diagram of PUE's

Signals were observed as close as possible to the pick-up plates by connecting 10 kΩ resistors right at the vacuum feedthrough connector of PUE L-8. Ten megaohm, 14 pF scope probes then connected a fast storage oscilloscope (in the first run) or waveform digitizer (second run) to the 10 kΩ resistors. A schematic diagram of the system is shown in Figure 1. The scope was observed in Building 914 and the control room via CCTV. The digitizer was read out in real time directly to a video monitor and stored data was transferred to a graphics terminal via an RS-232 data link. The F-20 wideband wall current monitor was observed simultaneously as an indicator of the true bunch profile.

1. Pick up plate
2. Ground shield
3. 2' of RG 62U, 93 Ω cable
4. Pulse transformer, $V_{out}/V_{in} = 1/10$
5. 1700' of RG62U between ring and control room, with double shield

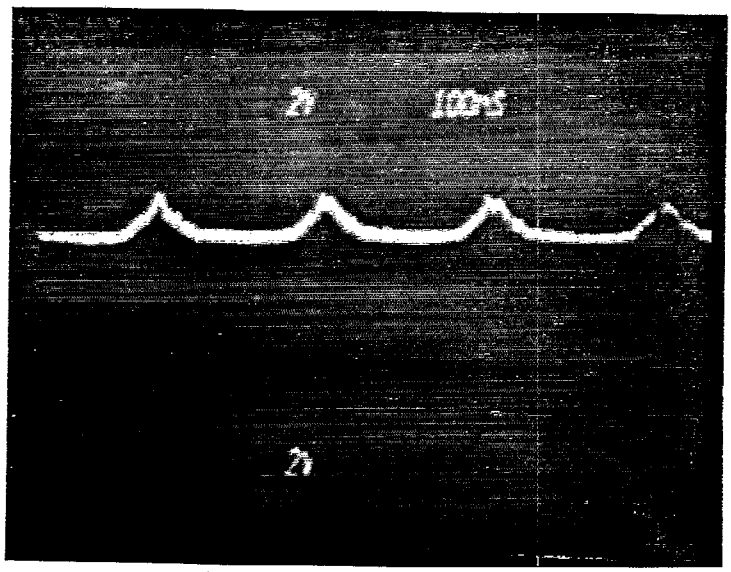
Figure 2. PUE signal.

Typical waveforms are shown in Figures 2 and 3. The first observation is that there is nothing pathologically wrong with the PUE signal. The baseline is well behaved with no trailing disturbance from one pulse influencing the next. What was observed, however, was a tendency for internal structure within the bunch to stimulate resonances or ringing in the PUE signal. Figure 4 is an example where the tight bunch (10 ns FWHM) near transition has excited an internal resonance(s) in the PUE which greatly distrorted the signal. Figure 4 represents the limit of the storge scope and CCTV technique. A better look at the signal was obtained in the second run with the digitizer in the ring. Figure 5 is a digitizer wavform output at essentially the same point in the cycle. The higher resolution (one sample per nanosecond) reveals even more structure. The digitizer waveform shown in Figure 6 is from the earlier point in the cycle (same as Figure 2) and shows much less distortion. It is clear that the fidelity of the PUE signal depends on the detailed structure of the bunch charge distribution. The most likely cause of distortions and ringing is the non-impedance matched cabling arrangement and termination scheme.

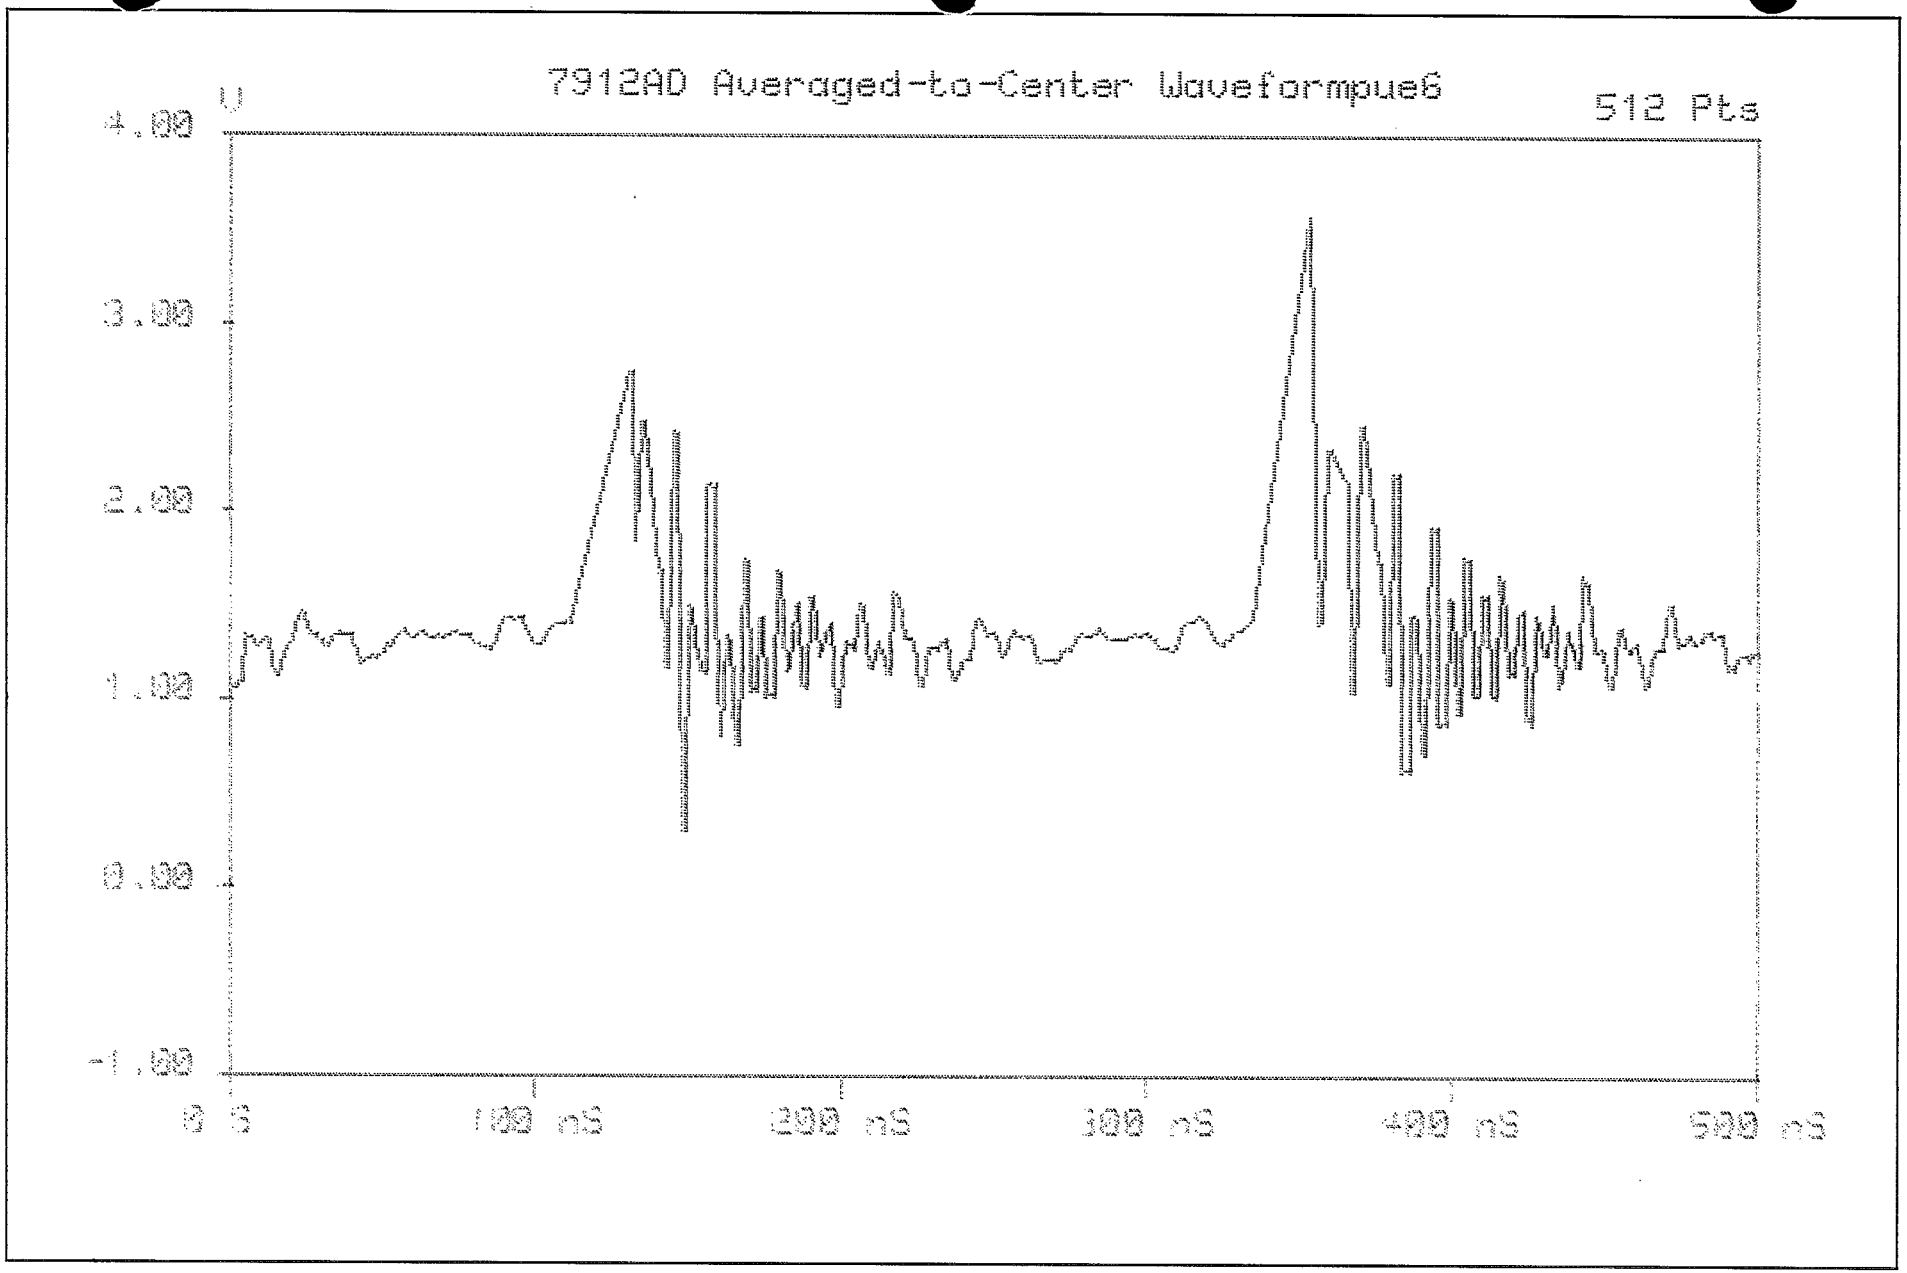
Some attempt was made to see the current in the RC network of L-8 simultaneously with observing the PUE signal. To do this, the RC network that connects the chamber to the magnet via 50 Ω was extended out of the magnet fringe field on a 50 Ω cable and the current monitored with a fast current probe. The results of this test are shown in Figures 7 and 8, which corresponds to PUE signals shown in Figures 5 and 6 respectively. It is clear that at least some of the high frequency structure seen in Figure 5 is correlated to currents that have gotten onto the outside of the chamber via the insulated flange.

Figure 5. Waveform digitizer output of PUE signal.

An imporant test for a future study would be to try to determine if some improvement of the PUE signal would arise from a completely conducting flange joint. This can be done by adding more strap around the joint and observing the PUE signal and the RC network current.

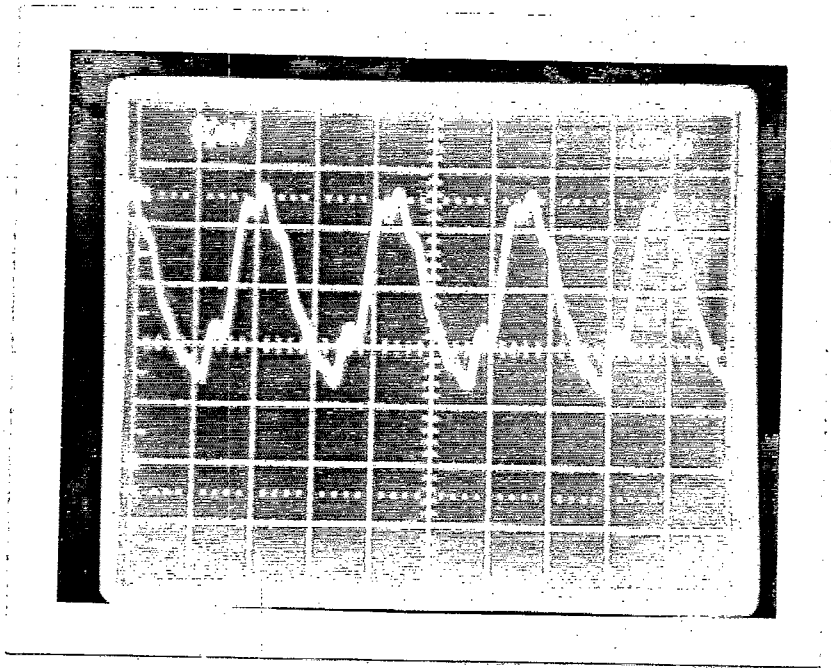
Figure 7. RC network current. Compare with Figure 5.

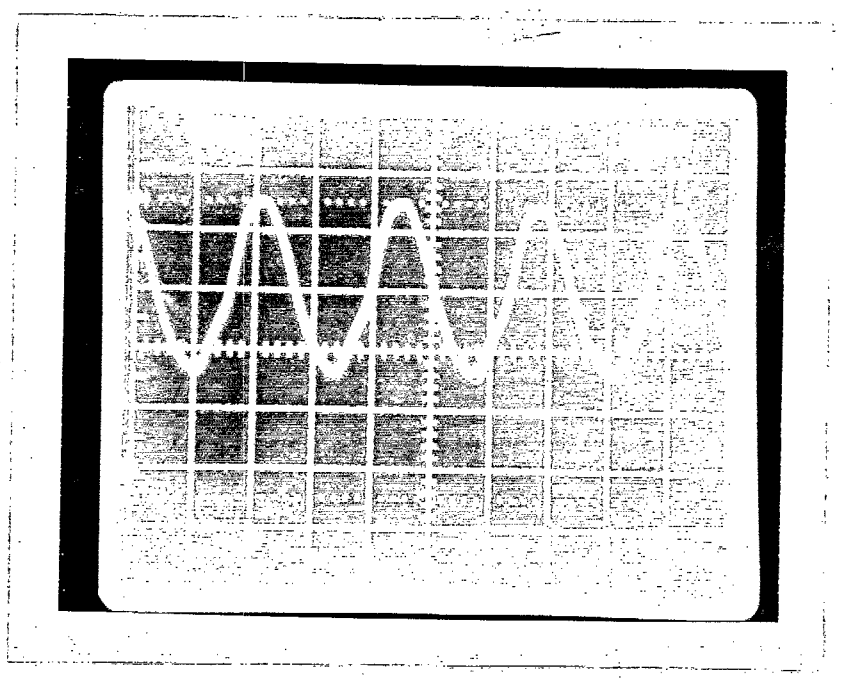
Figure 8. RC network current. Compare with Figure 6.

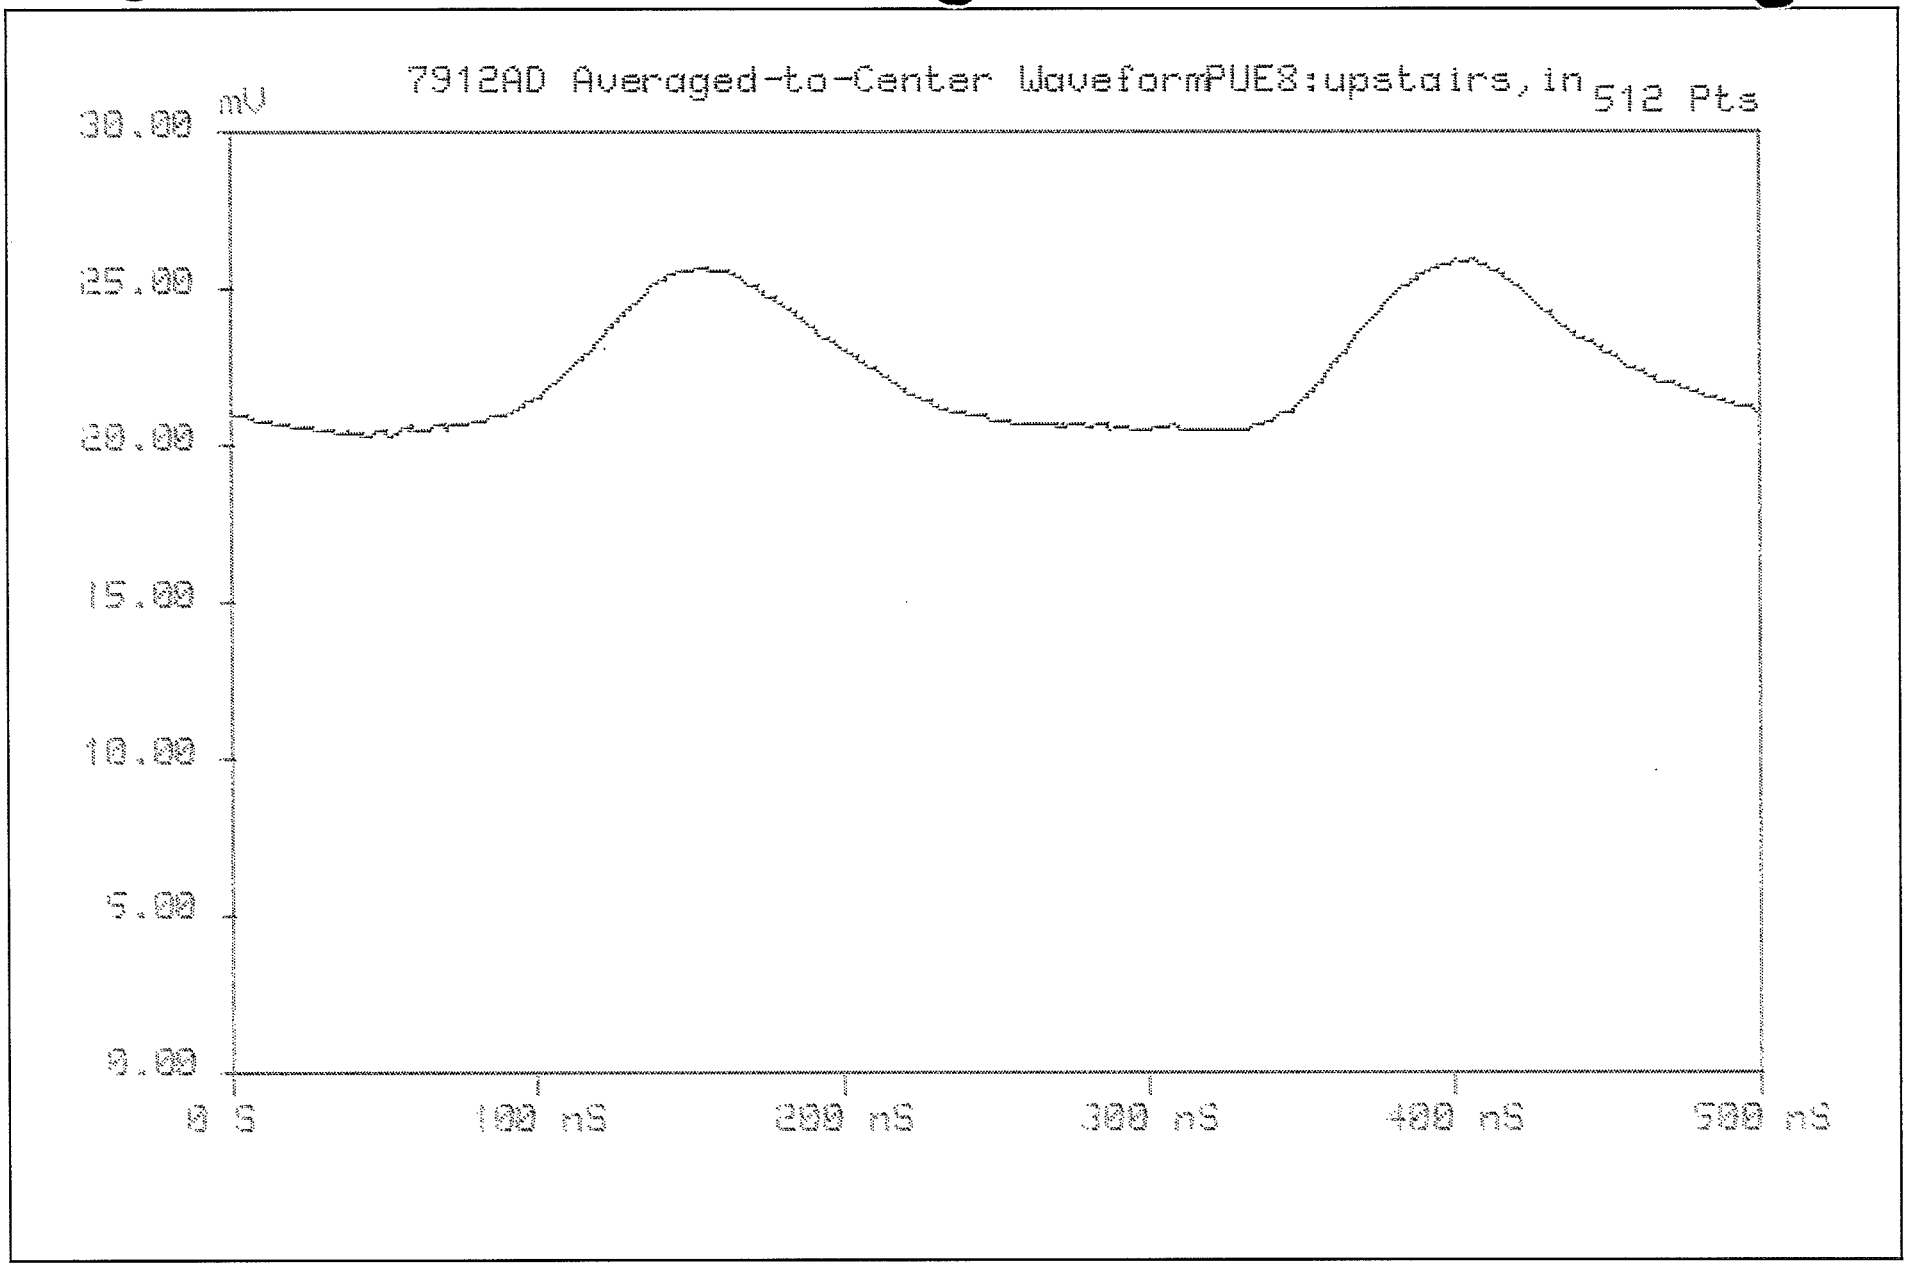
Finally, some attempt was made to assess the extent of signal degradation between the ring and the control room. Unfortunately specific measurements were not possible because we could not simultaneously measure in the ring and upstairs (we had only one digitizer). But by using the wall current monitor as a guide, similar signals were observed. Figure 9 is the PUE signal that arrives upstairs. It has passed through some RC filtering, a 100 into 1 impedance ratio pulse transformer, and 1700 feet of RG-62U cable. Not surprisingly, it is attenuated and heavily smoothed. One would not expect, and does not see, any fine structure similar to Figures 5 and 6. The relevant questions to ask are, has any necessary information been lost <u>and</u> has precisely the same thing been done to the other member of the $\pm x$ or $\pm y$ pair? The answer to both questions is probably no.

Figure 9. PUE signal as it arrives upstairs.
